| <b>ENGINEERING REPORT</b> | <b>Report #</b> | CE23-0606 |
| <b>Evaluation of R-VPX product to VITA 72<br/>vibration levels</b> | <b>Revision #:</b> | <b>A</b> |

Testing was performed on Amphenol's R-VPX Ruggedized VITA 46 connector to determine its ability to withstand VITA 72 vibration levels.

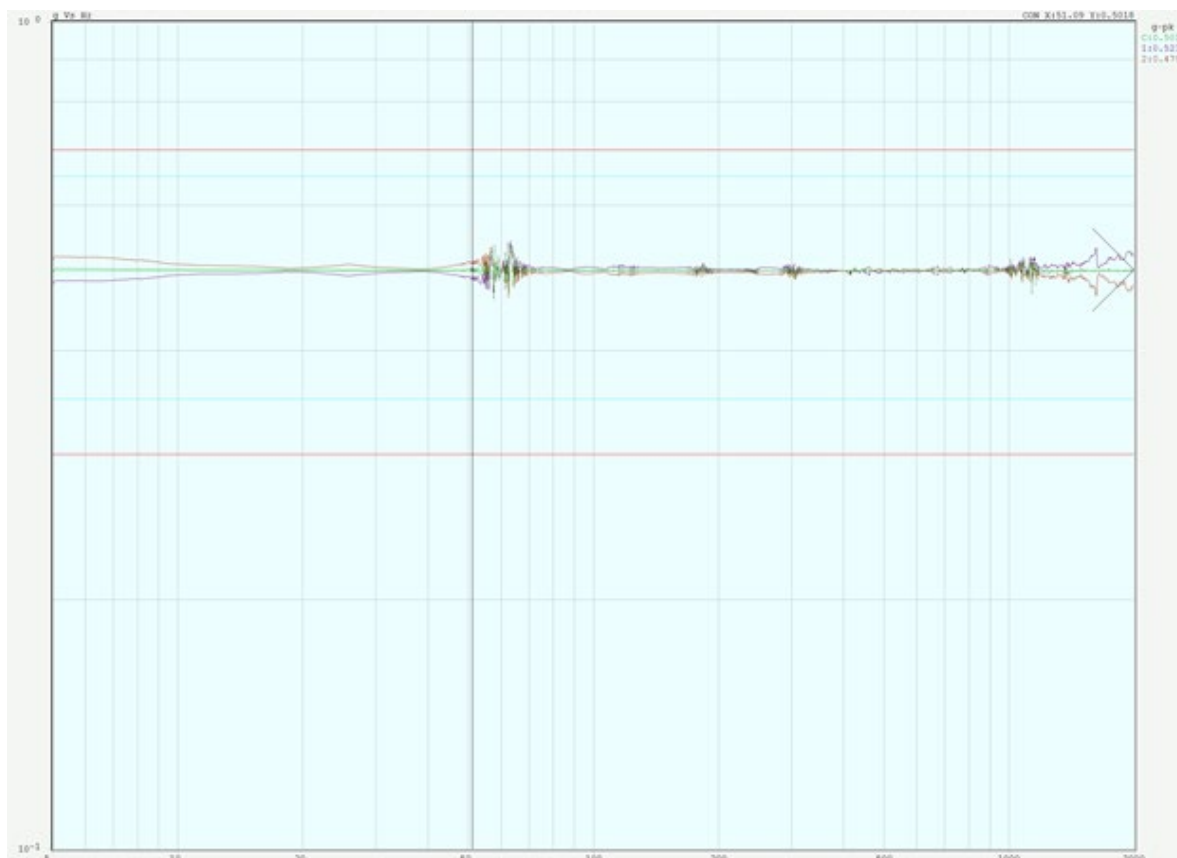
X axis sine sweep with fixture and backplane

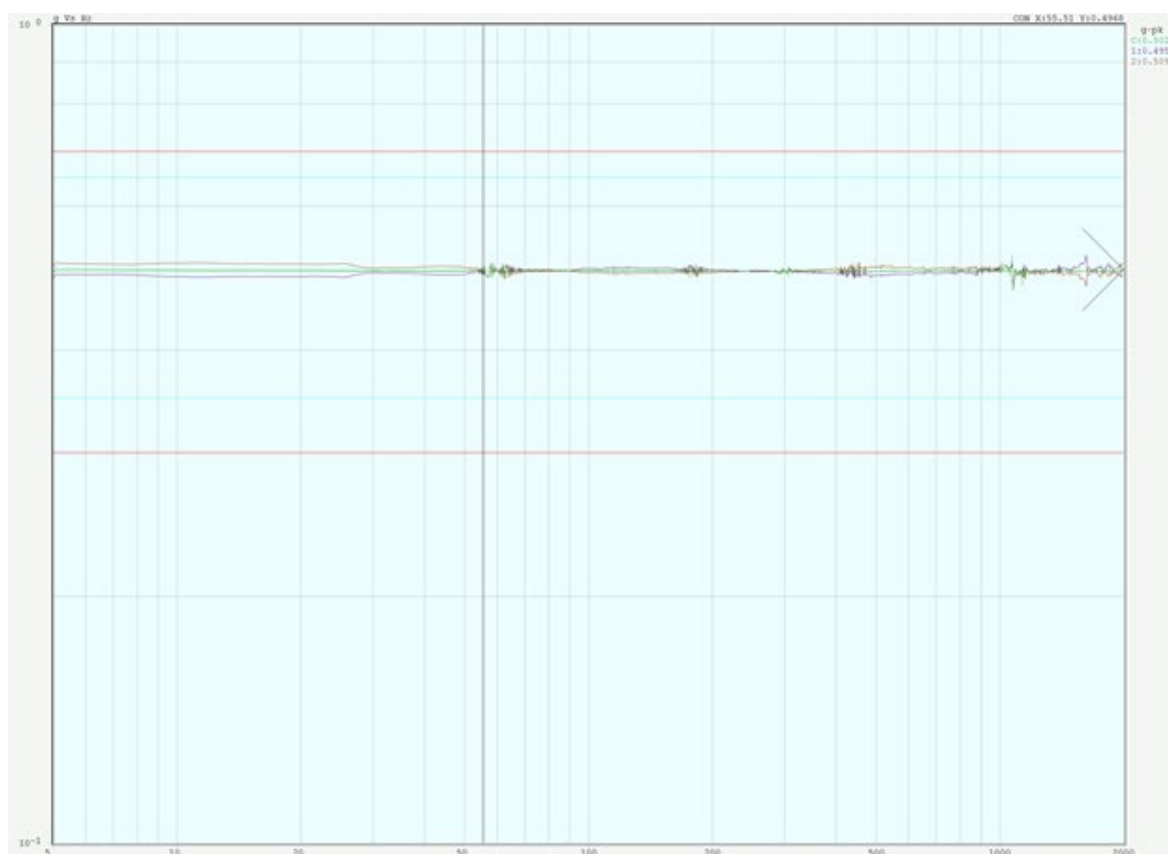
X axis Sine Sweep, Fixture, backplane and cables

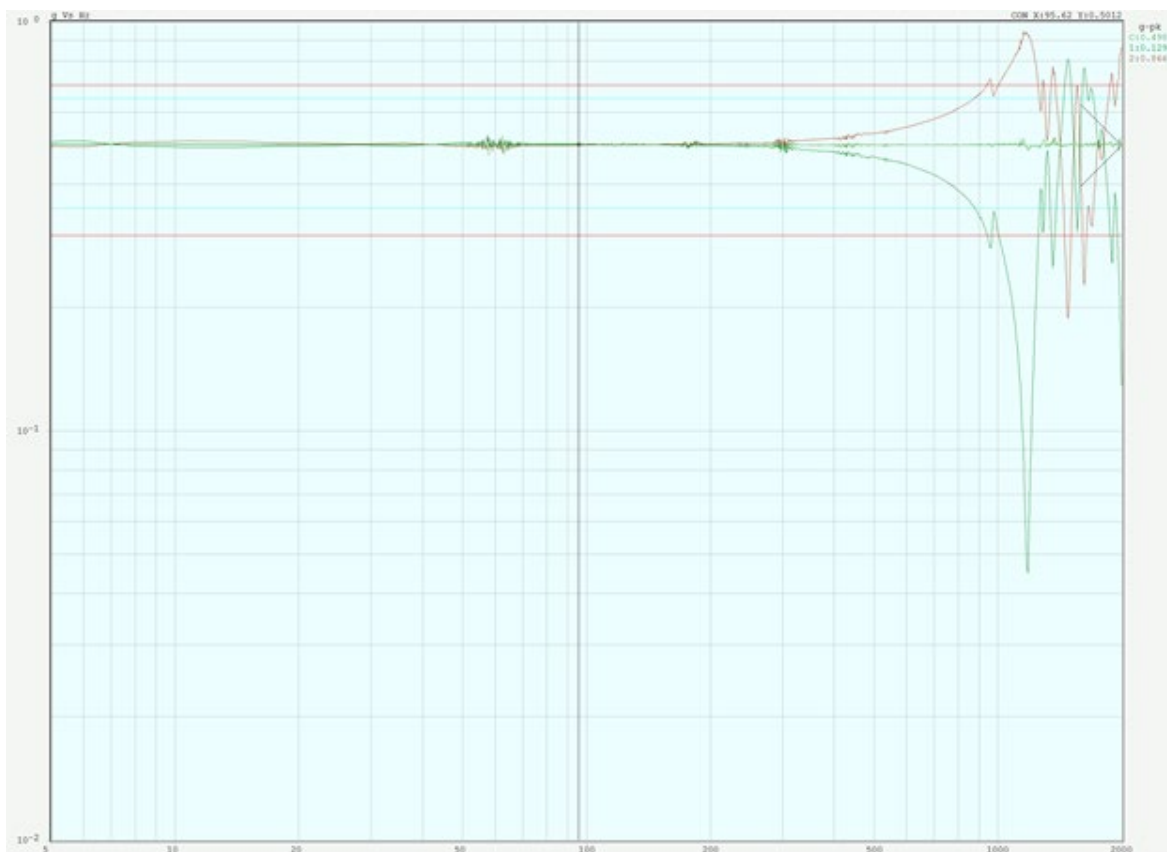
Z axis Sine Sweep with fixture and backplane
