Aerospace Operations 40-60 Delaware St. Sidney, NY 13838-1395		<b>CONTACTS</b>	Part No. PR-301 CONTACTS
Quality Approval: NEUBERGER Revision: 03/04/2015	Quality Standards CONTACT MACHINING & ASSEMBLY		Issue No. 003  PAGE 1 of 9

This Quality Standard applies to all contacts with regard to machining of the contact (Section 1) and assembly of contacts (Section 2.)

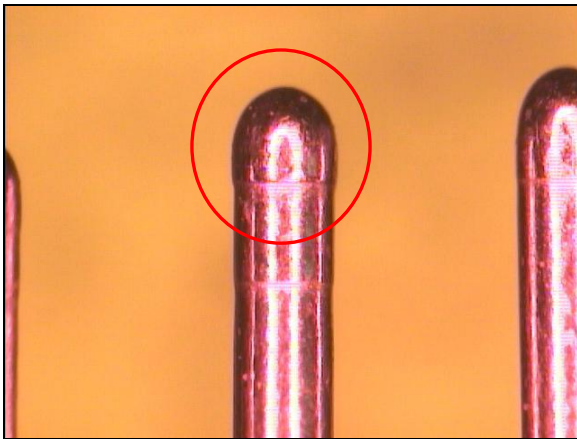
**Figure 1: Rejectable** *Bulb at tip of contact violates print dimension for the feature diameter.*

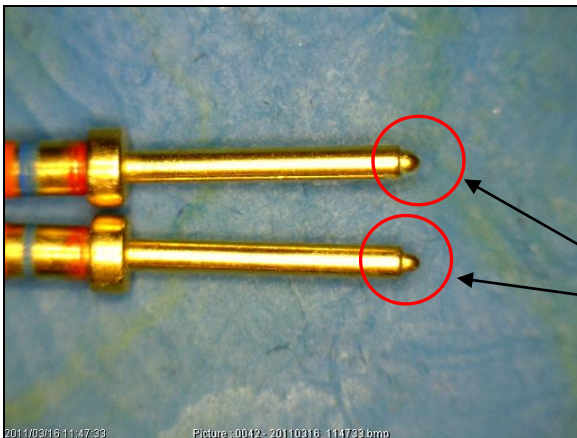
Note the reduction in diameter at the tip of the pin in Fig. 2 relative to profile and dimension of the pin from the engineering drawing clips shown above.

**Figure 2: Rejectable** *Malformed tip of contact mating pin violates print dimensions for the feature diameter*

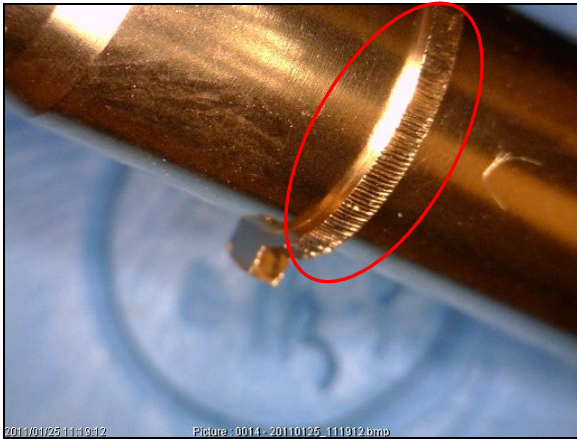
**Figure 3: Rejectable** Rough machining on the contact retention shoulder violates print dimensions for the feature as well as the surface finish.

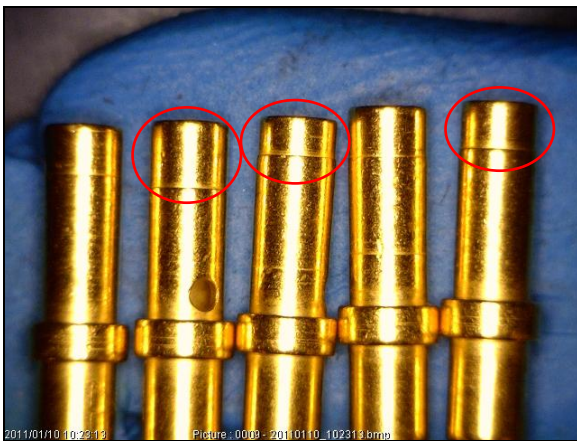
**Figure 4: Rejectable** Crimp well diameter violates print dimensions for the feature in the reduced diameter area.

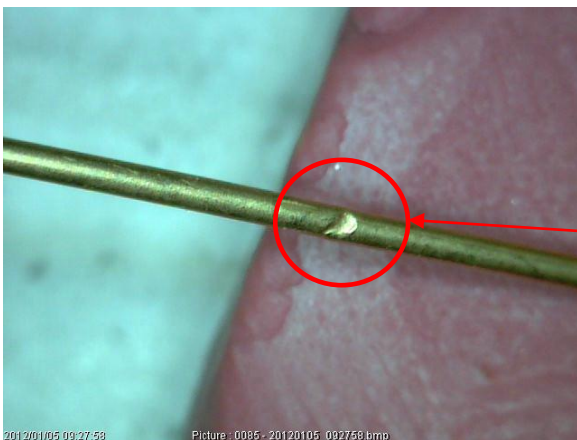
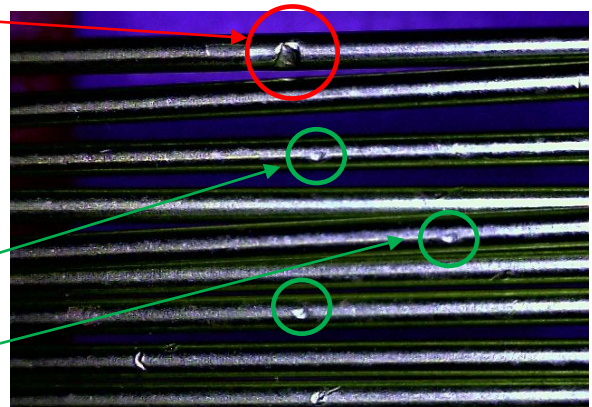
Note the much larger size of the defect below in red versus those in the green in the picture below.

**Figure 5: Rejectable** Damage to contact violates print dimensions

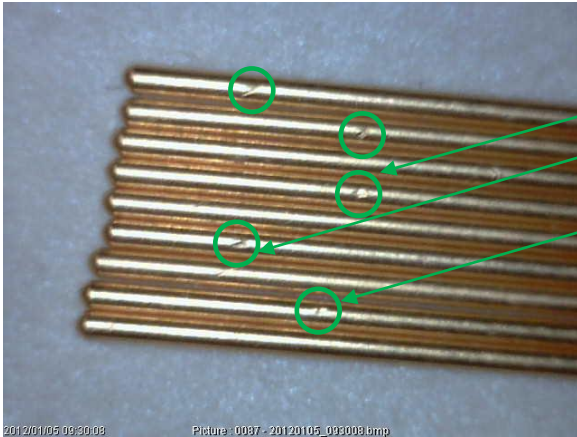
**Figure 6: Acceptable** Nicks in contact are minor and do not violate print dimensions or compromise functionality.

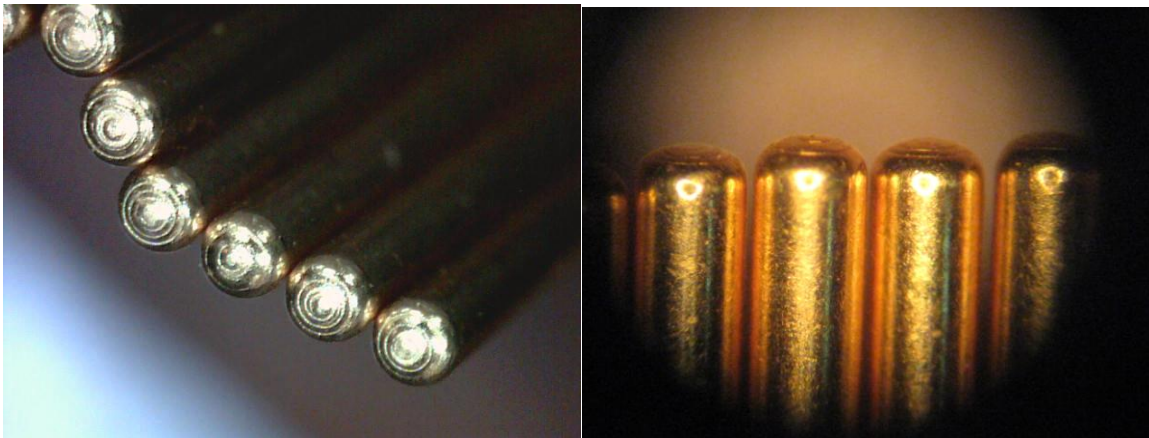
**Figure 7a & 7b: Acceptable** Swirl tool marks shown in Fig7a (profile view in 7b) do not violate print dimensions or compromise functionality of the part. Magnification of Fig7b is approximately 60X to actual size.

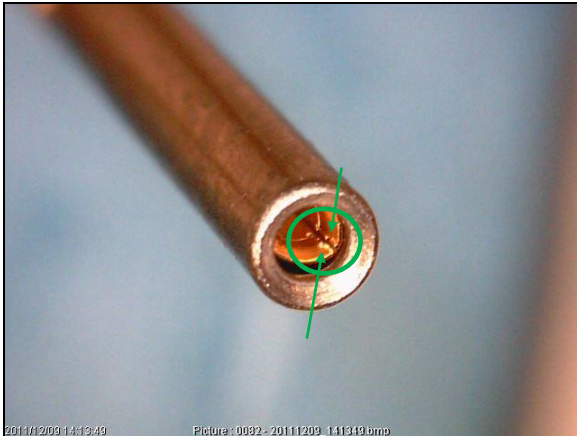
**Figure 8:** Acceptable Slot burrs at the top of the socket tine; burrs less than .003” and in a non-functional area.

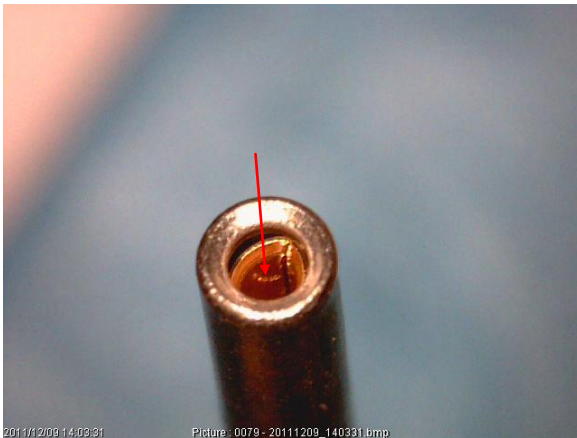
**Figure 9:** Rejectable Plated over FOD or chip from machining located in functional area of socket.

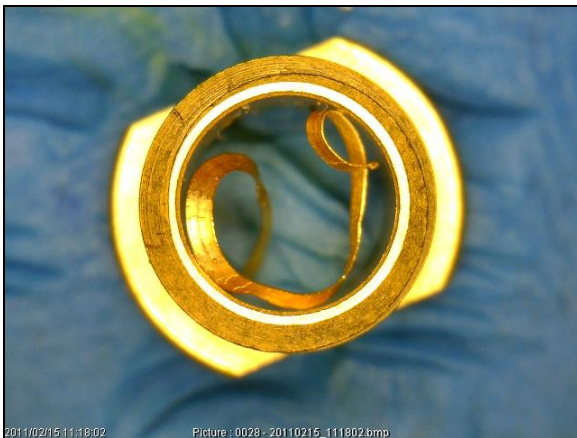
**Figure 10:** Rejectable Plated over chip from machining blocking functional inner diameter of the contact

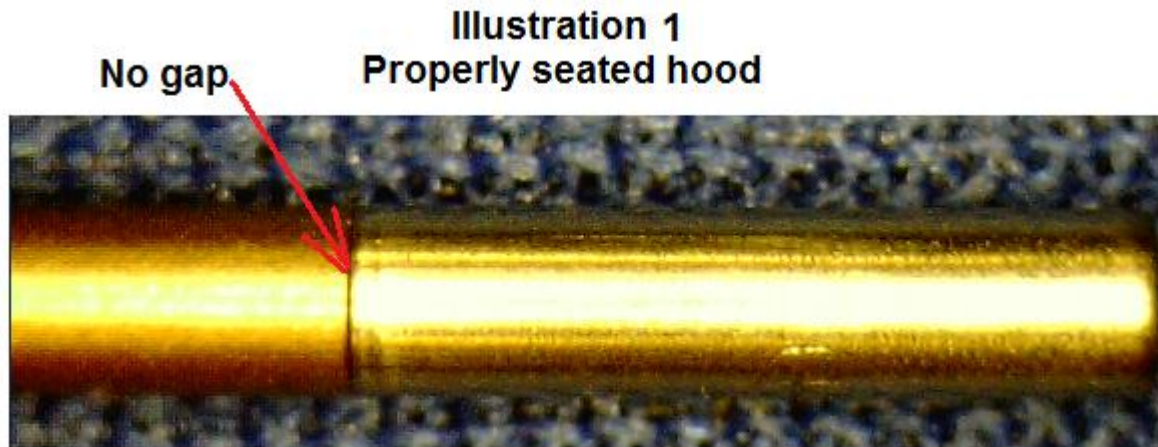
1. Orient and assemble a hood over the socket tine end of the contact and firmly seat it against the shoulder stop on the contact. Illustration 1 shows a properly assembled and seated hood with no gap prior to crimping.

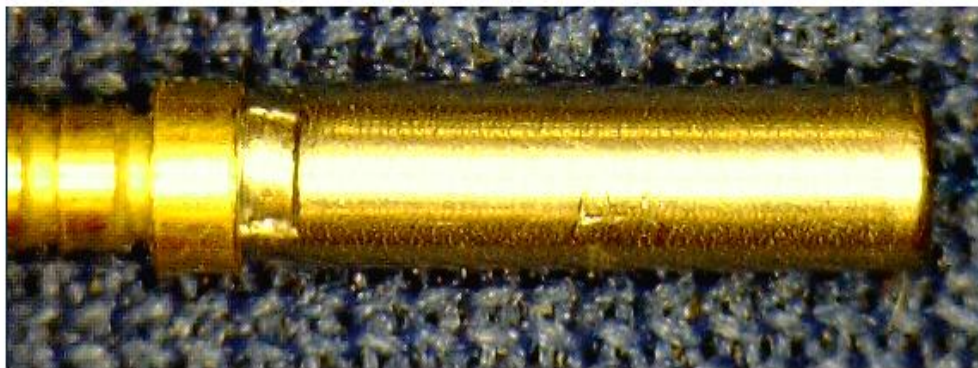
### Illustration 2

The hood is tightly crimped, it will not "click" or spin, the crimp indents are properly placed, the end of the hood is formed into the recess above the shoulder stop on the contact, the plating on the contact shoulder is not mutilated or damaged, and the hood is straight.

2. Place the assemble hood and contact, hood end first, into the crimping machine. Put a finger over the end of the contact to hold it downward against the stop rod at the bottom of the indenters, and cycle the crimper only once.
3. Remove the contact from the crimping machine. Refer to illustration 2 and perform a visual check to verify the following:
  - a. The crimp indents are properly positioned. The end of the hood must be securely formed into the recess at the shoulder of the contact
  - b. The plating on the shoulder of the contact must not be mutilated or disturbed.
  - c. The end of the hood butts against the shoulder of the contact.
  - d. The hood is not crooked.
  - e. The hood is tightly crimped and must not spin (rotate)
  - f. The hood must not “click” when pushed and pulled on the contact.

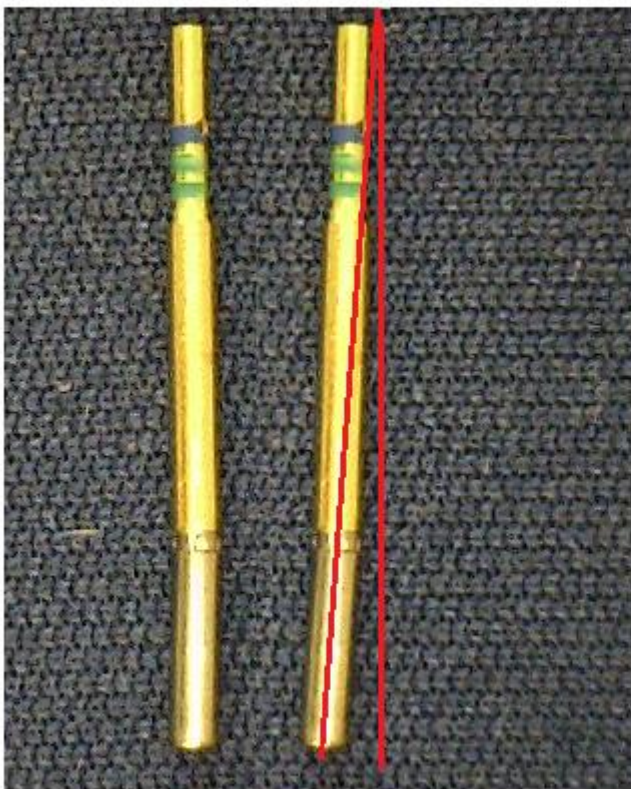
**Illustration 3  
Crooked Hoods**

Refer to illustration 3. Crooked hoods are usually caused by the hood not being properly / fully seated against the shoulder of the contact, or the contact not being held against the stop rod in the crimping machine during the crimping cycle. If not seated against the shoulder of the contact, the hood opening will not be concentric with the socket tines. A visual check of the mating end (using magnification) will show socket tines are not centered in the hood opening (as shown in illustration 4).

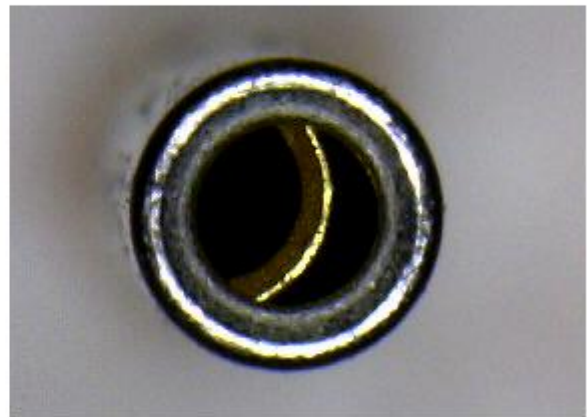
**Illustration 4  
Mating end view. Socket tines  
not centered in hood, caused by  
hood not seated/crooked hood.**

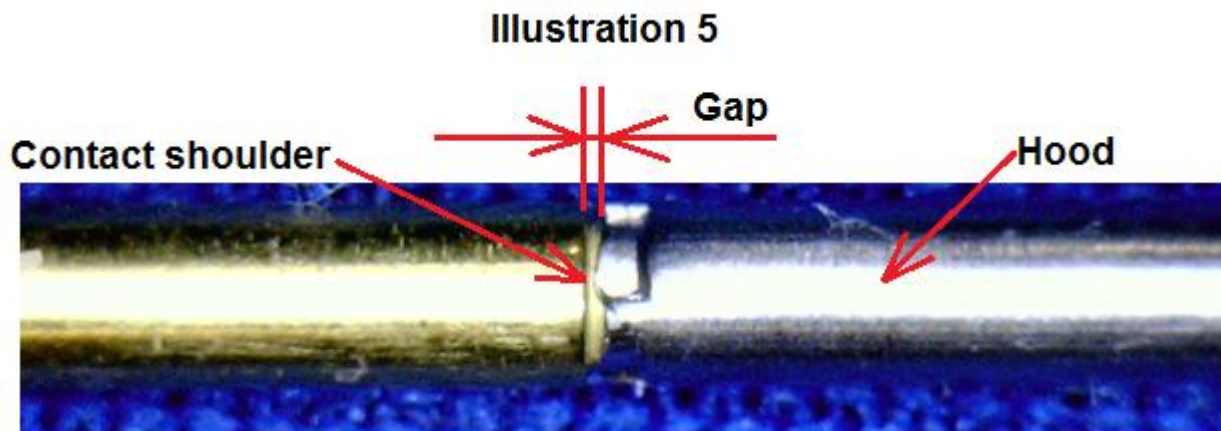
Illustration 5 shows an unacceptable gap between the hood and the shoulder of the contact.

The hood must seat against the shoulder.

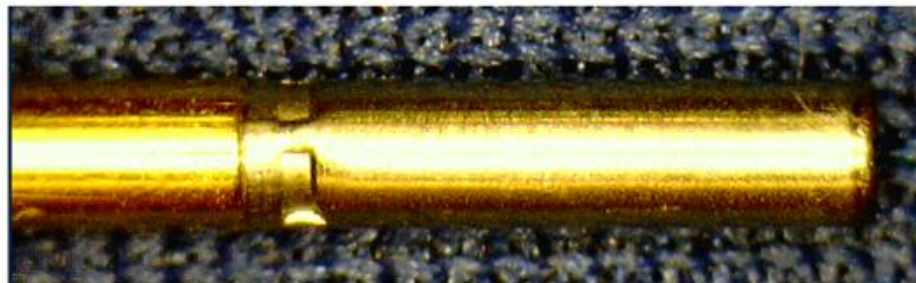
Illustration 6 shows improperly placed crimp indents. This is usually caused by the stop rod being positioned too low in the crimping machine, or starting the crimp cycle before the contact is seated against the stop rod of the crimping machine.

**Illustration 6**  
**Crimp indents are too far from contact shoulder**

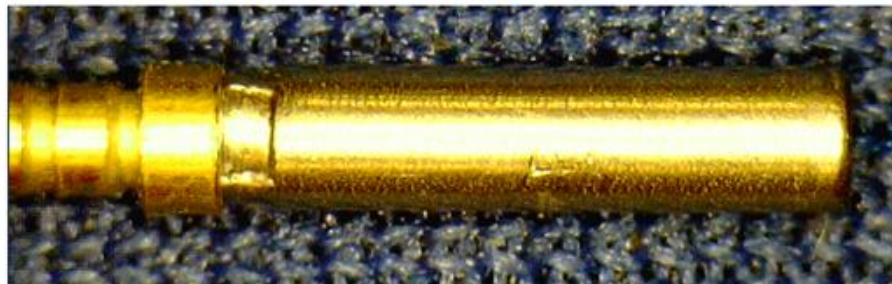
**Crimp indents properly positioned**
